ASSESSMENT OF ELECTRO-MECHANICAL COMPONENTS OF BAKOLORI SMALL HYDROPOWER PLANT FOR REFURBISHMENT AND
MODERNIZATION

ABSTRACT

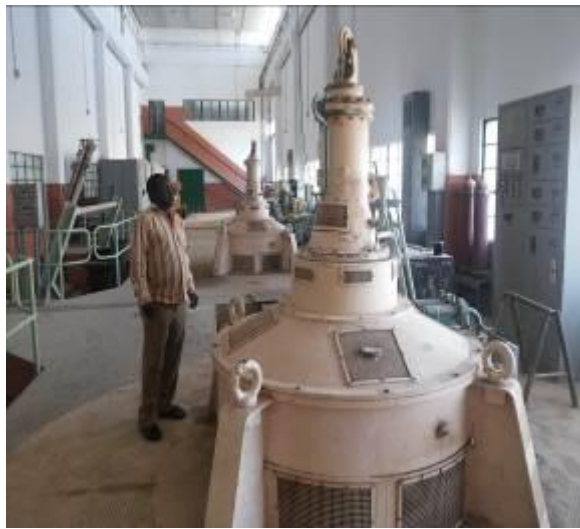
Figure 1: (a) Kaplan turbines (b) Wheel gate pump station (c) Hydraulic station (d) Tailrace

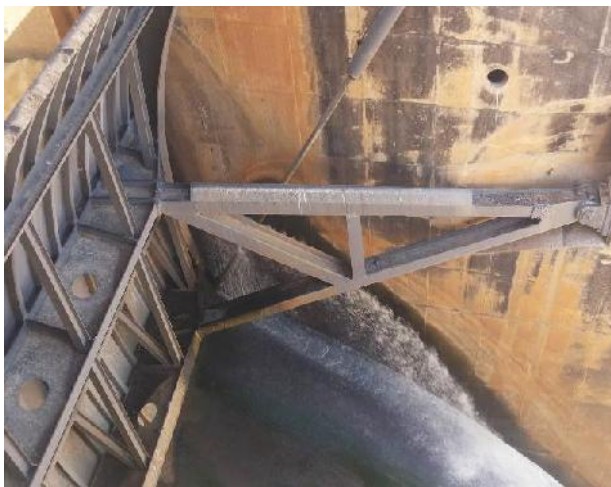
The main reason why one of the turbines was shut down is that that the self-priming pumping unit installed to evacuate leakage water from the turbine carbon seal of the coupler was damaged and allowed water seepages to mix with the oil of the turbine. This incidence caused severe damage to the turbine components over time as a result of rusting and corrosion of parts as shown in Figure 2.

Figure 2: (a) leakage at the wicket gate (b) leakage at the pump house

also in good conditions. Although the concrete structures at the dam site are still solid, serious leakage

of water at the wicket gates was observed. This is due to bad seals and minor cracks at welded joints.

- (i). The turbines should undergo major replacement of component parts and renovation but if the cost of this procedure is very high, outright replacement of the turbines with modern, high performance, slightly higher rated turbines of similar configuration should be carried out.
- (ii). Water leakage at the wicket gates and other sections should be tackled by replacing worn out seals, weak weldment should be corrected

and gate frames, gate bonnets and other structural members should be strengthened.
