## Geomorphological Characteristics of the Karadua River Basin Dutsin-Ma, Katsina State, Nigeria

### ABSTRACT

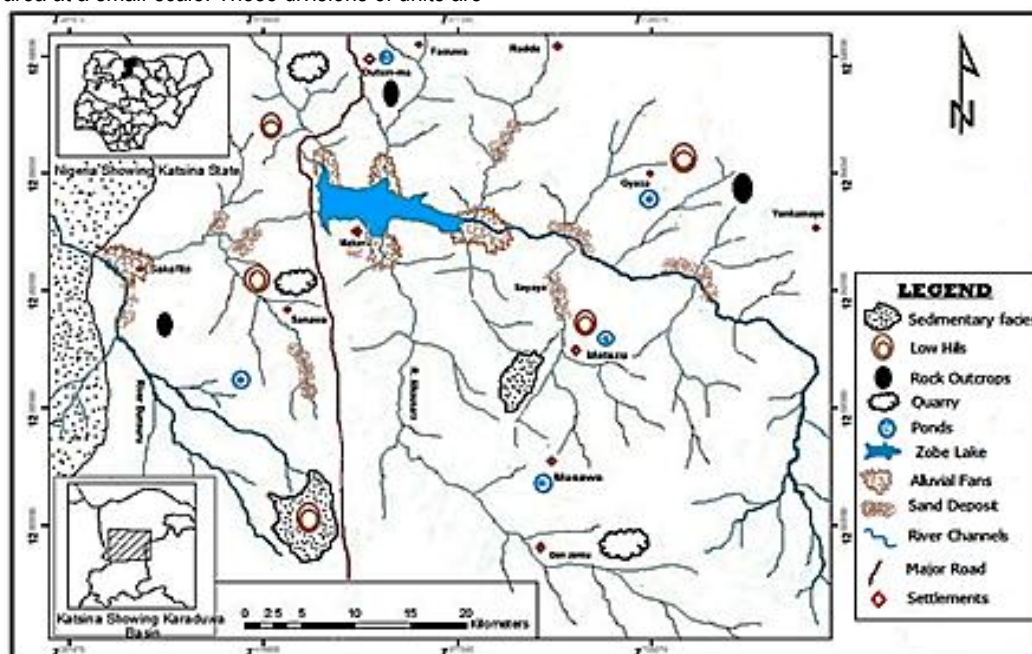
**Figure 1:** Geomorphological Map of Karadua River Basin (Study Area)

presented in Figure 1 below in order to have a generalized view of the geomorphological settings of the area.

From what could be seen in the map (Figure 1), the high plain or the upland areas occupied the eastern part, north-eastern and south-eastern regions of the study area. The area is vast but has a very gentle slope ranging from  $1^\circ$  to  $6^\circ$  towards the south west of the study area. These areas represent largely the upper course of the streams that form the drainage system in the catchment. Thus, the source of most of the drained water that collects in Zobe Lake.

Terrace formation occurs when different factors cause rivers to cut deeper into their valleys, leaving their former floors elevated above the active channel. This incision can happen gradually or suddenly, driven by increased flow energy, a lower base level, or reduced sediment load, which enhances the river's erosive power. Changes in climate or base-level adjustments that steepen the channel gradient can increase discharge and stream energy. In the study area, river terraces occupy the space between major and minor tributaries of the Karadua drainage system, varying in size according to local gully and stream behavior. This feature is represented in the geomorphological map of this study area as the portions intersecting the channels networks (Figure 1 above).

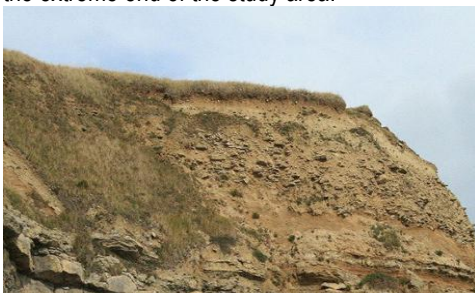
**Figure 2:** A small Dutsin-Kwaru Hill at Dutsin-ma (Source: Researcher – West of S/Gari 3km South of Zobe Dam 13/04/2023)

Within the upland Plains of this study area there are a number of hills. These are very low hills that rise in isolation and often occur at various distances away from one another. They as well appeared in the lowland plains but are distinguished by their sizes. At the eastern part they are a bit higher and broader. These features are either in form of earth material or with a mixture of rock fragments. The hills found in the north and eastern parts are characterized by rocky terrain. They are steeper than those at the other parts. Though they are all small hills, but some rise up to 35 meters above the ground level and occupies an area as large as 2500 – 35,000 m<sup>2</sup>. An example is the Dutsin Kwaru located directly eastern the large Quarry few kilometres south-western the Zobe Dam. This is shown in Figure 2. Residual hills composed of weathered materials and capped by laterites occur, but they are restricted to the northern part of Karadua basin at the extreme end of the study area.

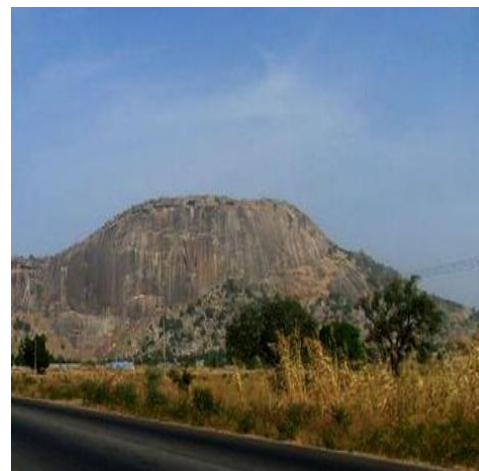
**Figure 3:** Showing the Gigantic Inselberge in Dutsin-ma town

An associated features found in this terrain are the prominent rounded rocky out crops and rocky terrain. These occurrences are dominated by the gigantic Inselberge at the center of Dutsin-ma town, from which it derives its name '*the Rock of Ma*'. Rocky outcrops form striking features in the landscape of most of the study area. They occupy almost all land use type areas, from settled area to farmlands etc. Dutsin-ma (Ma-Rock) is a large rocky conical peak (oval-like), a resistant granitic outcrop with steep sided slopes of almost 90° at the base. There are also minor occurrences of granitic rocks with a number of isolated outcrops all across the catchment. Examples are shown in Figure 3 and 4.

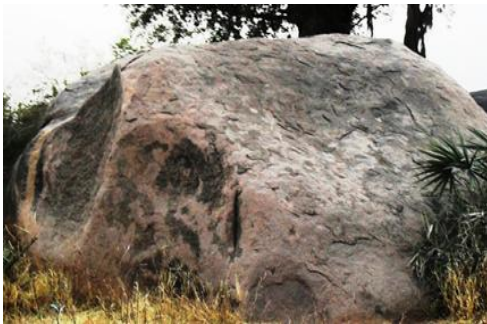
**Figure 4:** Showing an Isolated Rock outcrop in the Study Area

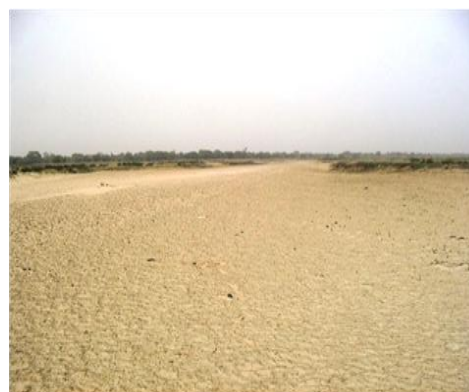
**Figure 5:** Wide storm Channel at upstream Karadua

The stream network also includes broad valleys known as storm channels. Within these shallow storm channels are deeply cut incised channels, which can be up to 2 to 3 meters wide. **Figure 5** below and **Figure 6** show the wide channels and the incised channels respectively.

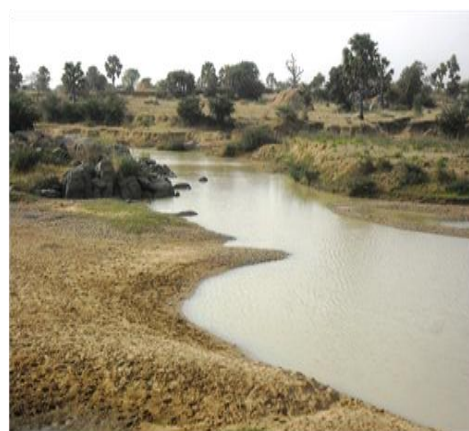
**Figure 6:** The incised channels cut within the wide storm channels

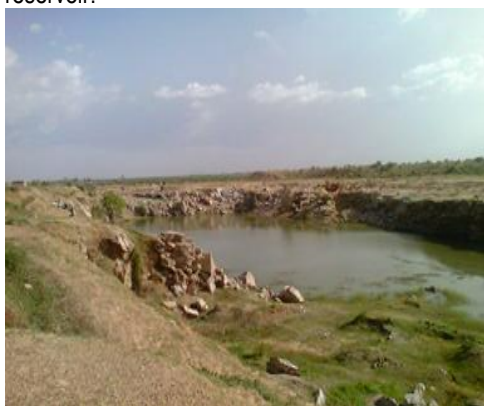
Figure 7: Showing Borrow Pit at Kakeri Village.  
Source: Researcher – At Makera Village East of Zobe Dam 28/05/2023

Within the major units described as Plains in this area also found lakes, quarries and burrow pits of various sizes and complexity as shown in Figure 7. The largest of these lakes is the Zobe Lake occupying the central area of the catchment. In the northern part of the area is the Dutsinma Dam Lake. This dam is small in area to just about 6.5% of the Zobe in comparison and has created a small basin of its own in the same northern part of the region. These are the only Lakes associated with streams specifically meant to feed them.

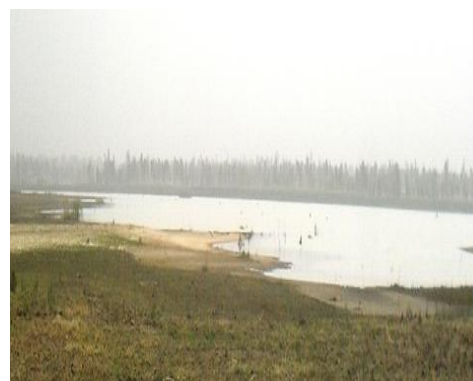
Figure 8: Showing a lake with water storage near Makera Village

Depending on their water supply and bottom clay material, the lakes and basins may be used as water storages, Aquatic life habitats, for animal drinking and for domestic use (example in

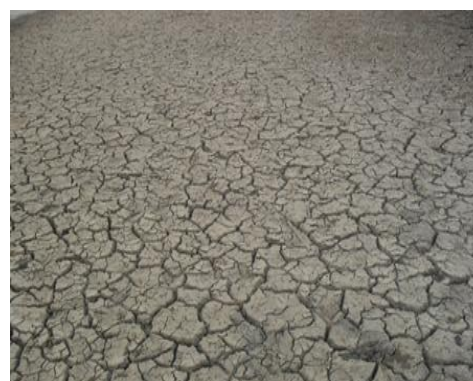
Figure 9: Dry bed's cracking clay Material in a lake near Musawa Town

Figure 8 below). The dry lake beds are dominated by organic rich fine sediments which form cracking clay soils and calcareous in nature (see Figure 9). The cracked material varies in composition according to the nature of the lake sediments. For example the shallow Lake at the higher plains of the east near Musawa town is mainly fine sand, whereas others, for example those at the downstream areas are fine clayed.

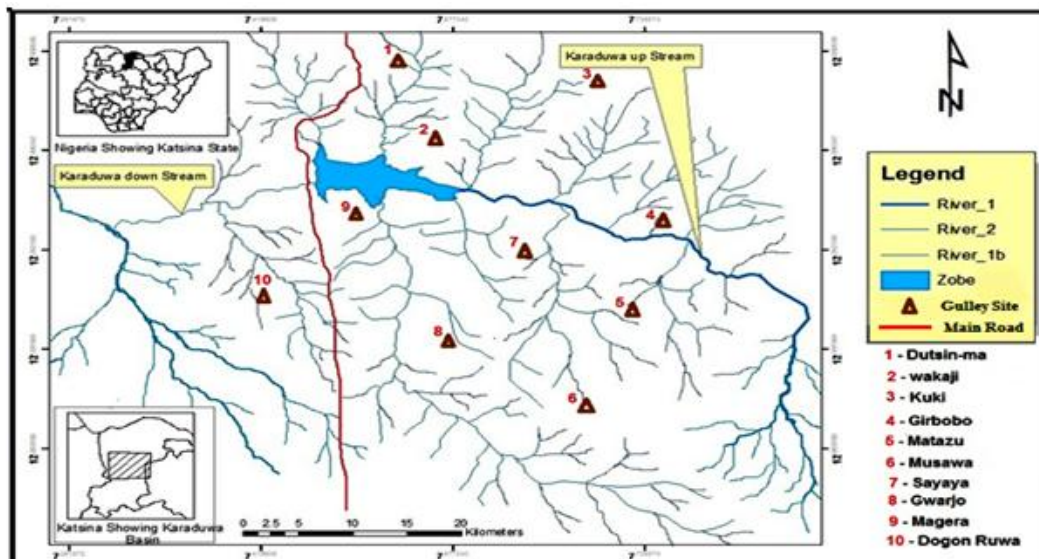
**Figure 10:** Locations of Gully Sites Measured in the Field (Source: Sport 4 Imagery, 2008)

During the field survey for this study, several gully sites were identified and examined across the study area. The spatial distribution of these gullies is presented in Figure 10 below.

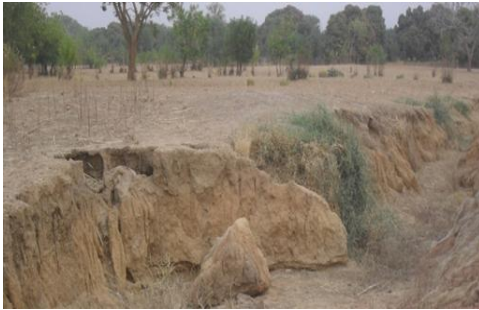
**Figure 11:** Showing an Active Gully near Dutsin-ma Town (**Source:** Researcher – Along Wakaji-D/ma Rd. N/E of Zobe Dam 20/09/2023)

The basic geometric variables of the gullies were measured following the appropriate technique described in the methodology part of this work. The cross-sectional information of the various gullies was computed by taking in to consideration their latitudinal and longitudinal locations, and topographical heights (elevation). Table 1 below presents the results of the measurements and computations. Example of such gullies studied is also shown below in Figure 11.

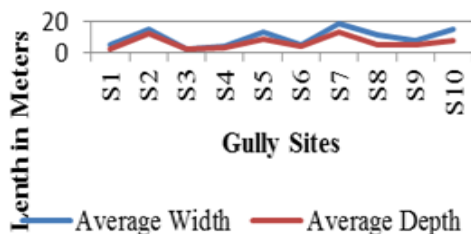
**Figure 12:** Mean width and depth of gully

Table 1 indicates that among the gullies measured, site S2 at Wakaji is the largest in terms of overall size, as well as mean depth and width. This gully has a striking U-shape, with sides resembling cliffs and reaching a depth of up to 6 meters. Its shape and dimensions are attributed to the local soil conditions in the area. The second largest is site S10, which, with a cross-sectional width of 68.6 meters. The smallest gully, in terms of cross-sectional area, is S3, measuring just 4.7 square meters. Figure 12 further illustrates these characteristics, showing clear interrelationships

between the gullies and the correlation between average depth and width within each one.

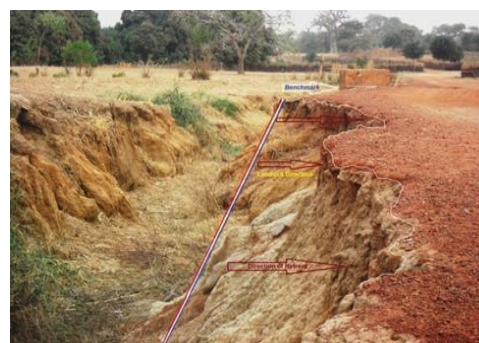
**Figure 13:** Sampled Gully Retreating from a Benchmark

The measurements in this work were achieved by using specific gully sites as samples. That is gullies with marked demarcations which are constructed or made at certain known period, and currently the edge have now retreated landward leaving just a sign of the former bank. Figure 13 shows one of the sample gullies measured and also used to demonstrate the field technique for the method used. This was achieved because of the nearby culvert and embankment constructed along the channel which is used as the Benchmark.

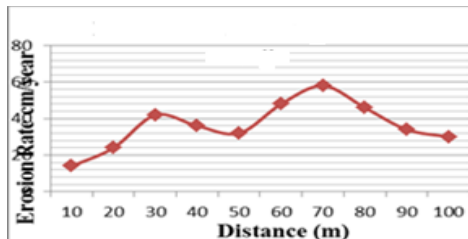
**Figure 14:** Erosion Rate at Wakaji

Despite the fact that most gully sides cut and retreat in a high rate, there are locations where erosion rate is relatively low. This is why the average results presented in the table are not significantly very high. There are locations identified as erosion hot spots with a rate of retreat up to 72cm/yr along Wakaji gully site.

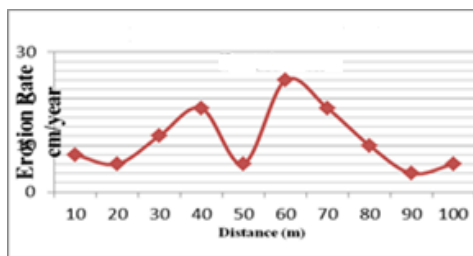
**Figure 15:** Erosion Rate at Dutsinma

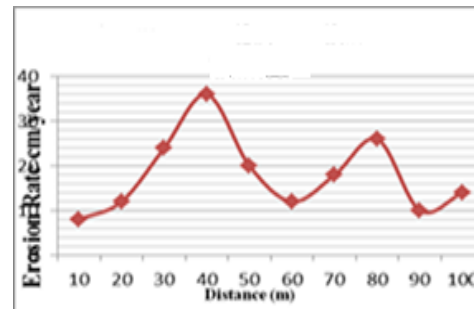
**Figure 16:** Erosion Rate at Makera

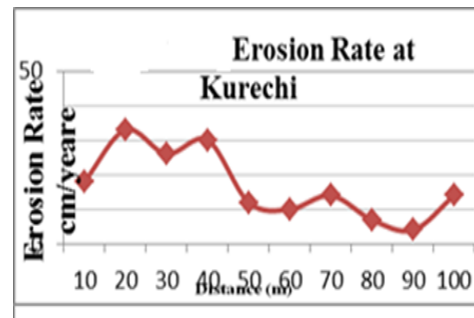
**Figure 17:** Erosion Rate at Kurechi
