## Geomorphological Characteristics of the Karadua River Basin Dutsin-Ma, Katsina State, Nigeria

### ABSTRACT

*The presentation here so far analyses the geomorphology of the Karadua basin which is the study area. Three (3) major geographical regions were identified and mapped out. These are the upland plains, Lowland plains and the Riverine plains which formed the major division of the Geomorphological map of the area produced for the purpose of this work. Within these major divisions, other smaller landforms were identified and studied. They ranges from the highest hill or rock outcrop to the lowest lying borrow pit or quarry which are the common feature of the area. The geomorphology of the Karadua Basin, which is generally classified as homogenous undulating plains, was found to be a reflection of many natural as well as anthropogenic processes of the past and in current times. The common processes in operation were identified and the most spectacular features resulted were identified and studied. The common geomorphologic processes are denudation and the most common are rill and gully erosion. These were found to have wrecked many places and affected land use surfaces to the

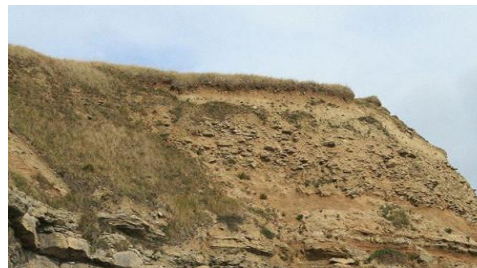
**Figure 2:** A small Dutsin-Kwaru Hill at Dutsin-ma (Source: Researcher – West of S/Gari 3km South of Zobe Dam 13/04/2023)

They are steeper than those at the other parts. Though they are all small hills, but some rise up to 35 meters above the ground level and occupies an area as large as 2500 – 35,000 m<sup>2</sup>. An example is the Dutsin Kwaru located directly eastern the large Quarry few kilometres south-western the Zobe Dam. This is shown in Figure 2. Residual hills composed of weathered materials and capped by laterites occur, but they are restricted to the northern part of Karadua basin at the extreme end of the study area.

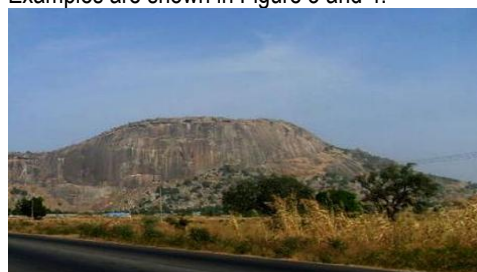
**Figure 3:** Showing the Gigantic Inselberge in Dutsin-ma town

An associated features found in this terrain are the prominent rounded rocky out crops and rocky terrain. These occurrences are dominated by the gigantic Inselberge at the center of Dutsin-ma town, from which it derives its name '*the Rock of Ma*'. Rocky outcrops form striking features in the landscape of most of the study area. They occupy almost all land use type areas, from settled area to farmlands etc. Dutsin-ma (Ma-Rock) is a large rocky conical peak (oval-like), a resistant granitic outcrop with steep sided slopes of almost 90° at the base. There are also minor occurrences of granitic rocks with a number of isolated outcrops all across the catchment. Examples are shown in Figure 3 and 4.

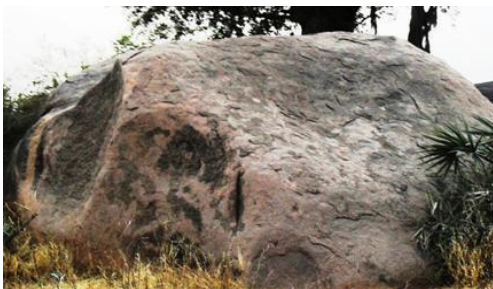
**Figure 4:** Showing an Isolated Rock outcrop in the Study Area

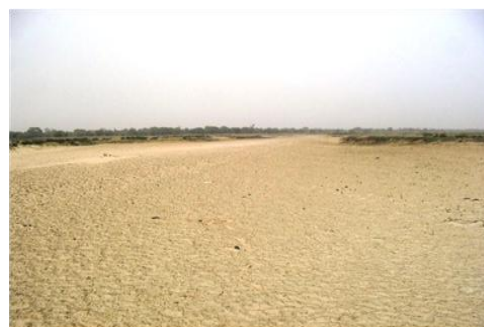
**Figure 5:** Wide storm Channel at upstream Karadua

The stream network also includes broad valleys known as storm channels. Within these shallow storm channels are deeply cut incised channels, which can be up to 2 to 3 meters wide. **Figure 5** below and **Figure 6** show the wide channels and the incised channels respectively.

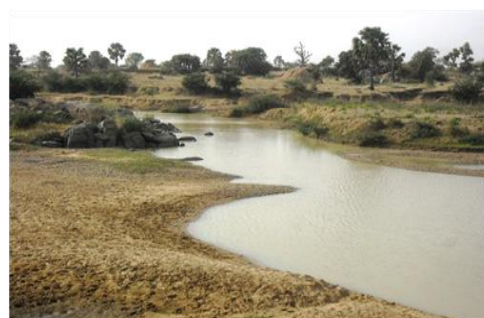
**Figure 6:** The incised channels cut within the wide storm channels

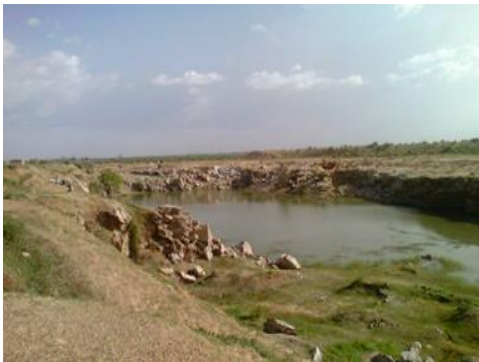
Figure 7: Showing Borrow Pit at Kakeru Village.  
Source: Researcher – At Makera Village East of Zobe Dam 28/05/2023

Within the major units described as Plains in this area also found lakes, quarries and burrow pits of various sizes and complexity as shown in Figure 7. The largest of these lakes is

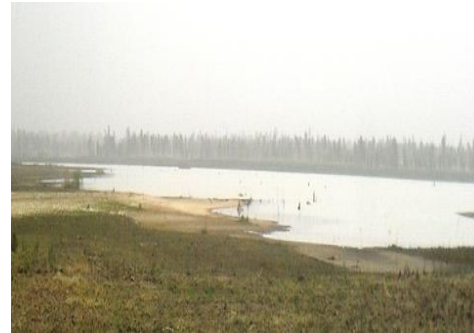
Figure 8: Showing a lake with water storage near Makera Village

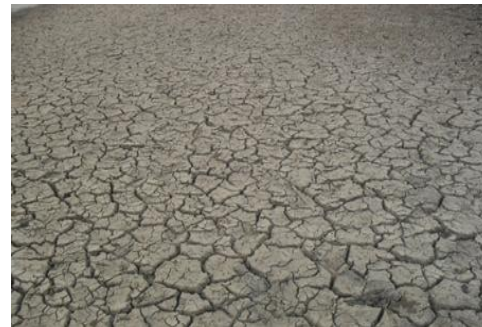
Figure 9: Dry bed's cracking clay Material in a lake near Musawa Town

example the shallow Lake at the higher plains of the east near Musawa town is mainly fine sand, whereas others, for example those at the downstream areas are fine clayed.

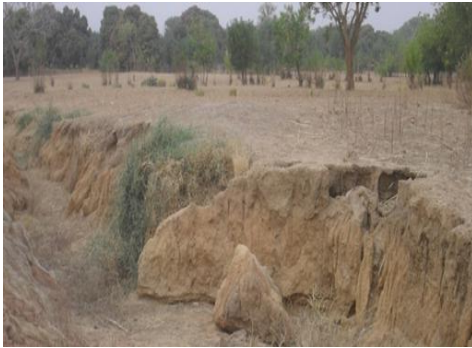
**Figure 11:** Showing an Active Gully near Dutsin-ma Town (**Source:** Researcher – Along Wakaji-D/ma Rd. N/E of Zobe Dam 20/09/2023)

During the field survey for this study, several gully sites were identified and examined across the study area. The spatial distribution of these gullies is presented in Figure 10 below. The basic geometric variables of the gullies were measured following the appropriate technique described in the methodology part of this work. The cross-sectional information of the various gullies were computed by taking in to consideration their latitudinal and longitudinal locations, and topographical heights (elevation). Table 1 below presents the results of the measurements and computations. Example of such gullies studied is also shown below in Figure 11.

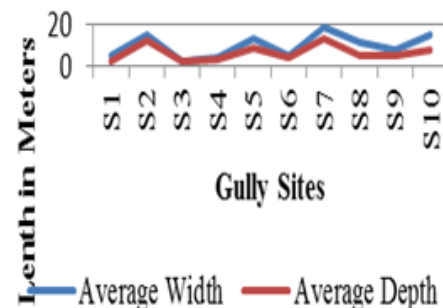
**Figure 12:** Mean width and depth of gully

Table 1 indicates that among the gullies measured, site S2 at Wakaji is the largest in terms of overall size, as well as mean depth and width. This gully has a striking U-shape, with sides resembling cliffs and reaching a depth of up to 6 meters. Its shape and dimensions are attributed to the local soil conditions in the area. The second largest is site S10, which, with a cross-sectional width of 68.6 meters. The smallest gully, in terms of cross-sectional area, is S3, measuring just 4.7 square meters. Figure 12 further illustrates these characteristics, showing clear interrelationships between the gullies and the correlation between average depth and width within each one.

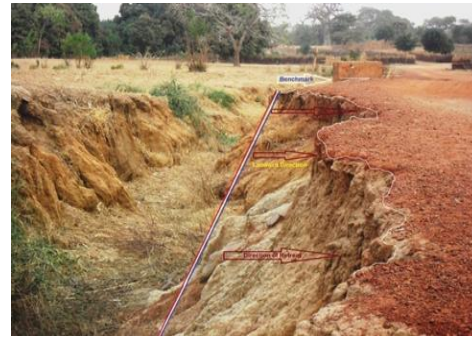
**Figure 13:** Sampled Gully Retreating from a Benchmark

The measurements in this work were achieved by using specific gully sites as samples. That is gullies with marked demarcations which are constructed or made at certain known period, and currently the edge have now retreated landward leaving just a sign of the former bank. Figure 13 shows one of the sample gullies measured and also used to demonstrate the field technique for the method used. This was achieved because of the nearby culvert and embankment constructed along the channel which is used as the Benchmark.

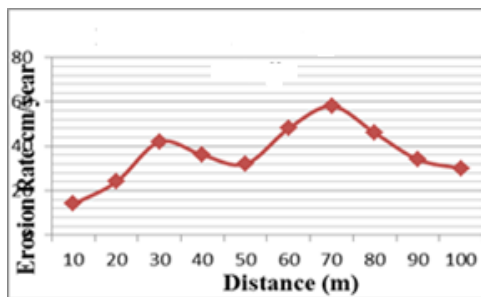
Figure 14: Erosion Rate at Wakaji

a standard deviation of 14. The lowest value was found in Dutsinma with only 11 cm/yr and a standard deviation of 08. Figures 14, 15, 16 and 17 give a sketch of the rate of retreat in the four different gully sites at 100 meters segments each. These figures present a picture of the curvatures produced by erosion in each segment in the course of their retreat. The presence of gullies suggests that terrestrial erosion is significant in this location. It is again observed that vegetation cover plays significant role in regulating rate of erosion.

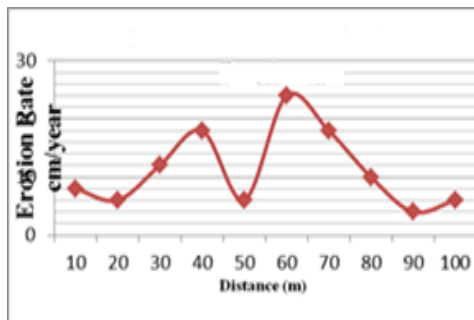
Figure 15: Erosion Rate at Dutsinma

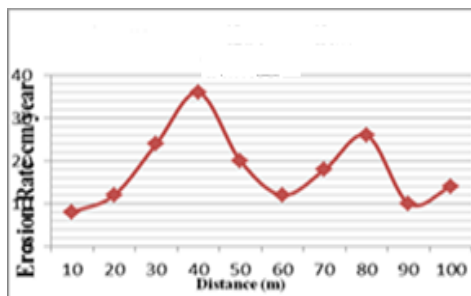
Figure 16: Erosion Rate at Makera

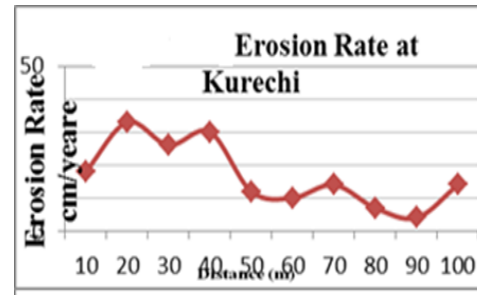
Figure 17: Erosion Rate at Kurechi
